(14) NWC-TM-3064

(6) AIR-LAUNCHED MISSILE
STRUCTURAL FAILURE/DAMAGE STUDY.

by
(10) C.F. Jawor
Aeromechanics Division
Systems Development Department

(11) APRIL 1977

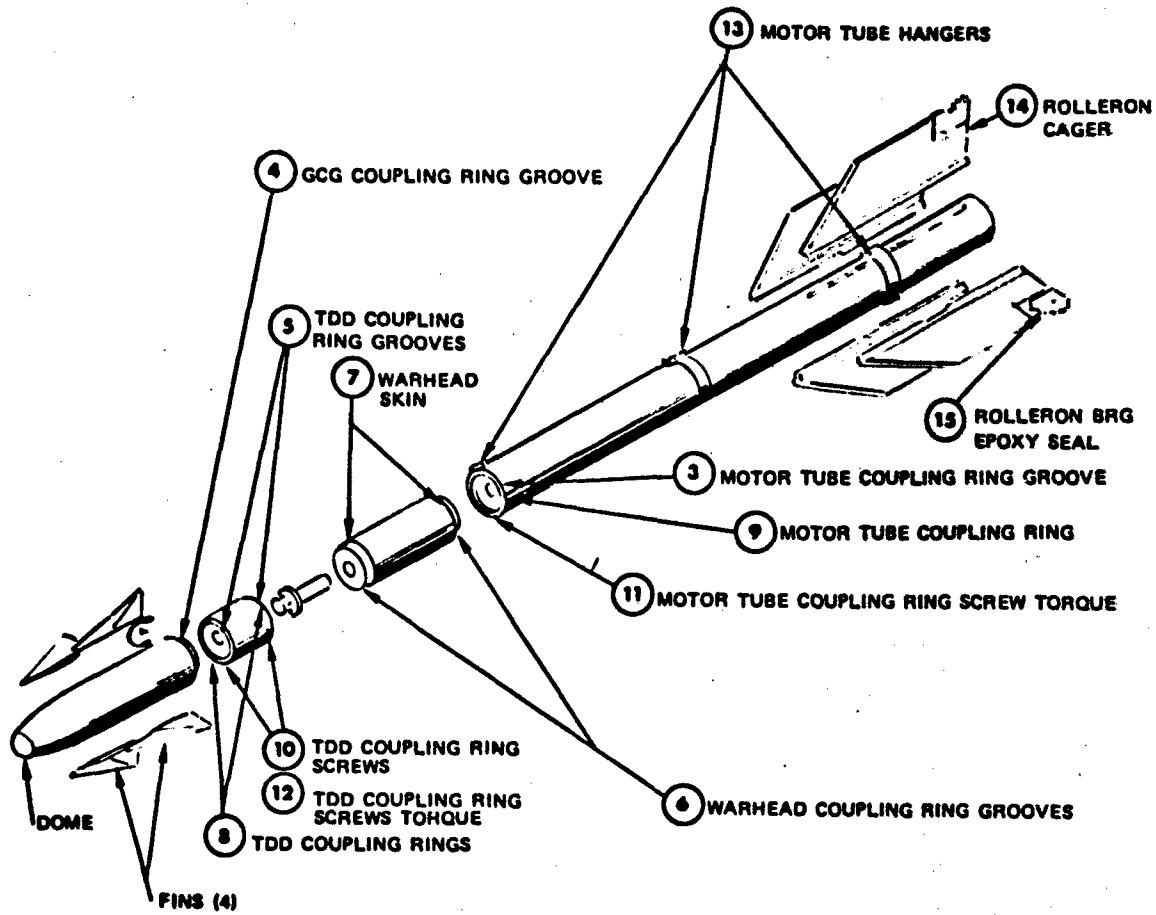
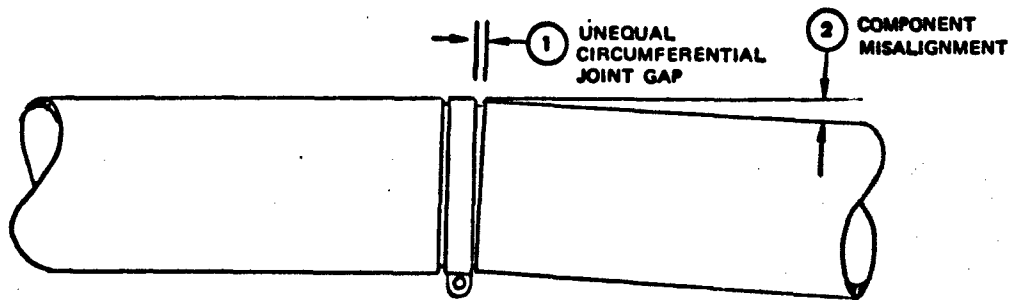
FIGURE 1. AIM-9C/9D Missile Failure Points.

do	Joint motor tube coupling ring groove	Crack	Flight load overstress	Lock fin (canard) control surfaces during captive flight	Crack detected after captive flight	1
do	GCE coupling ring grooves	do	do	do	do	1
do	ITD coupling ring grooves	do	do	do	do	1
do	Warhead coupling ring grooves	do	do	do	do	1

TYPICAL DEFECTIVE COUPLING RING JOINT

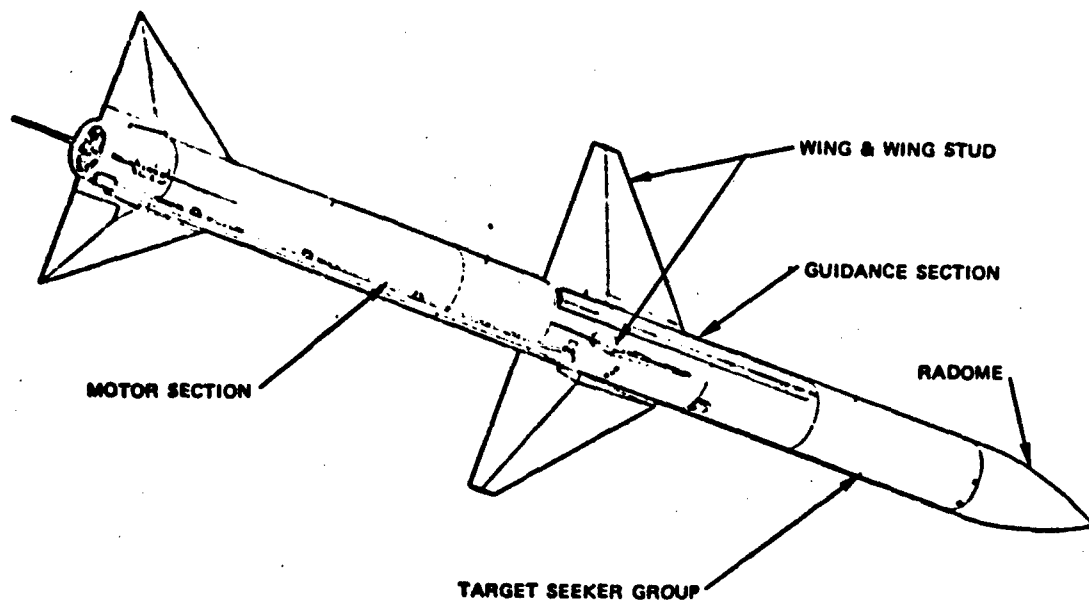
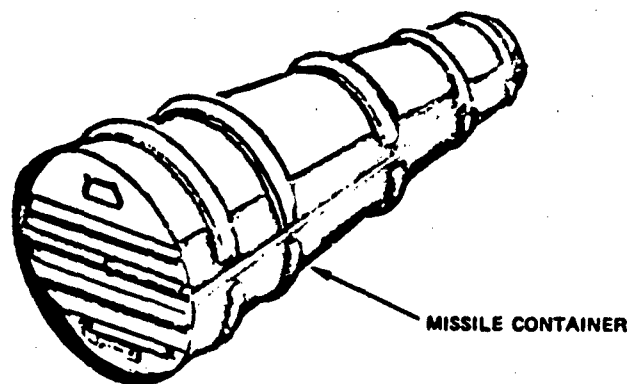
FIGURE 2. AIM-7 Missile Damage/Failure Points.

AIM-7D (SPARROW)	Wing	Wing lost during captive flight	Overstress due to flutter--wing unlocked	...		15
AIM-7D AIM-7E AIM-7E2	Wing stud	Wing clips & wing studs broken loss of wings	Flutter instability wings flap against stops causing overstress on studs	Wing clips to hold wings stationary during captive flight	Intermittent incidents date back to early 60's. Occurred on F4B aircraft. Failure could not be repeated when monitored during flight tests	16

Specific types of failure/damage are shown as a percentage of number of inspections in Table VI. Only the top nine failure/damage percentages are shown. The SPARROW (AIM-7) wing hub or lock damage exceeds the next type of damage reported by a factor of 5.
